# Manhole Inspection Summary

Manhole # S13Q\_\_023MH

**Inspection** ☐ Is Incomplete Rating: **4) Poor**

**Location** Address: **2833 Sunset dr**

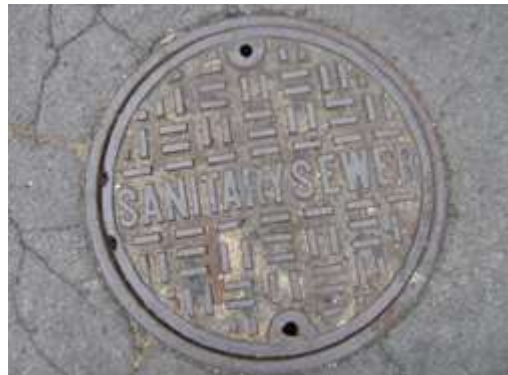
Type: **Sanitary** Condition: **Sound** Cover Material: **Cast Iron**

cover pic

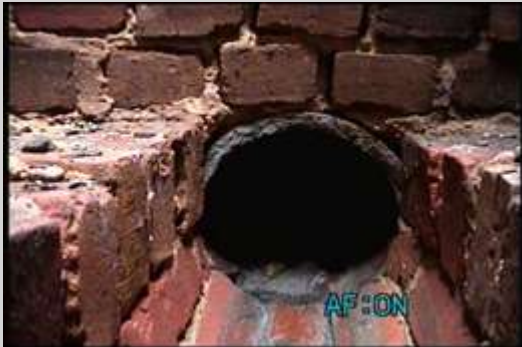
12 O'Clock Outflow

Pipe Height: **8.4** (in.) Rod and Bar (Angled)  
Pipe Material: **Clay** ☐ Pipe Lined  
Invert Depth: **10.30** (ft.) Flow Characteristics: **Fast**  
Deposits: ☒ None ☐ Mud ☐ Sludge ☐ Debris ☐ Grease  
Silt Depth: **0** (in.) Deposits Extent:  
Infiltration: **None** Pipe Seal Cond: **Sound**

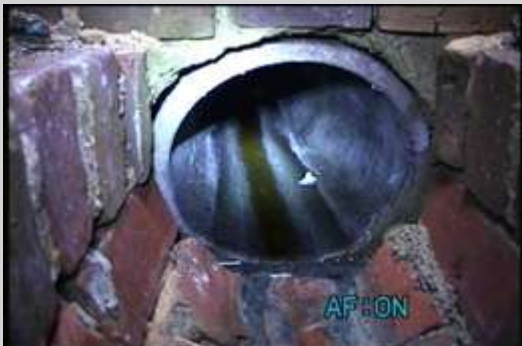
6 O'Clock Inflow

Pipe Height: **8.4** (in.) Rod and Bar (Angled)  
Pipe Material: **Clay** ☐ Pipe Lined  
Invert Depth: **10.04** (ft.) Flow Characteristics: **Fast**  
Deposits: ☒ None ☐ Mud ☐ Sludge ☐ Debris ☐ Grease  
Silt Depth: **0** (in.) Deposits Extent:  
Infiltration: **None** Pipe Seal Cond: **Sound**
